### ASHI HOME INSPECTION REPORT

Property address: 10716 - 51st St NE

Inspection date: Tuesday, January 7, 2025

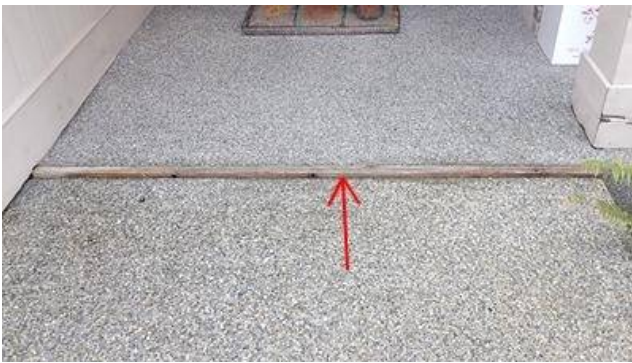
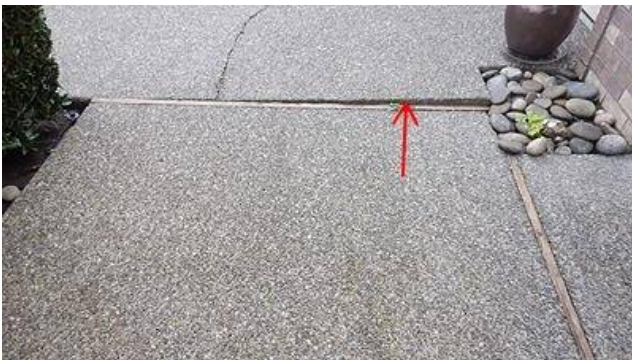
2) *Minor Concern* - Settlement was observed in the entry walk, between the entry porch and the driveway. Part of the driveway has also settled with the walk. Typically, these areas have settled and stopped. The settled walk sections have created trip hazards at the entry porch and the driveway. For safety reasons, recommend repairing these areas to eliminate the trip hazards. For example; by using slab jacking technics to raise the settled walk and driveway sections. Recommend that a qualified contractor repair this concern as necessary.

Photo 2-1 Trip hazard at concrete divider.

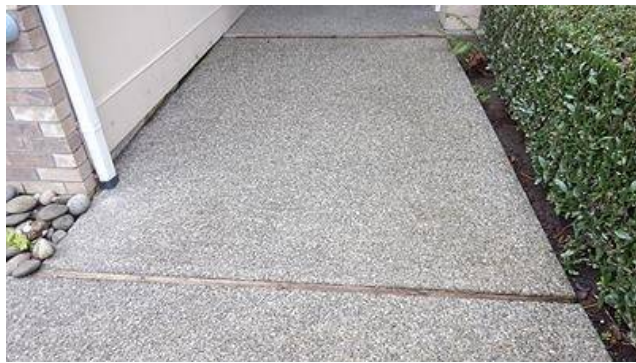
Photo 2-2 Settled walk section.

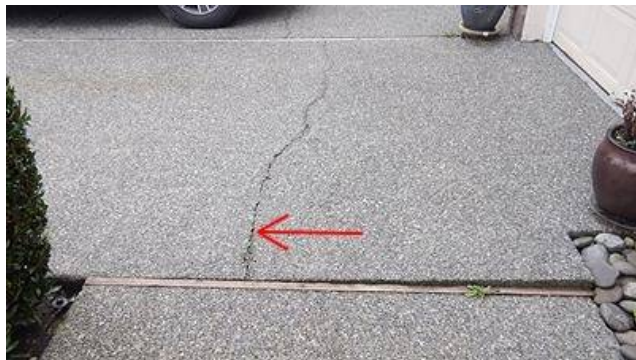
Photo 2-4 Cracked and settled driveway.

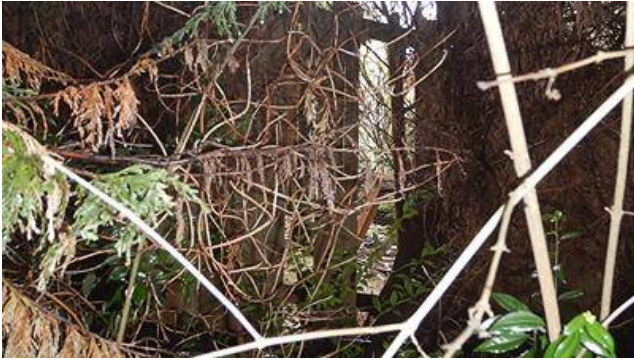
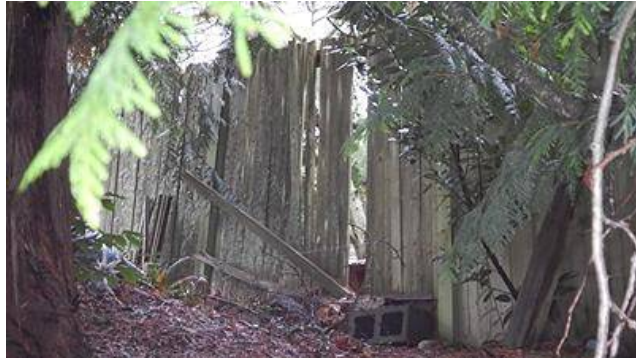
Photo 3-1

3) *Repair/Replace* - The fencing was damaged, falling down and/or rotted along the north sides of the property. The damaged sections should be replaced.

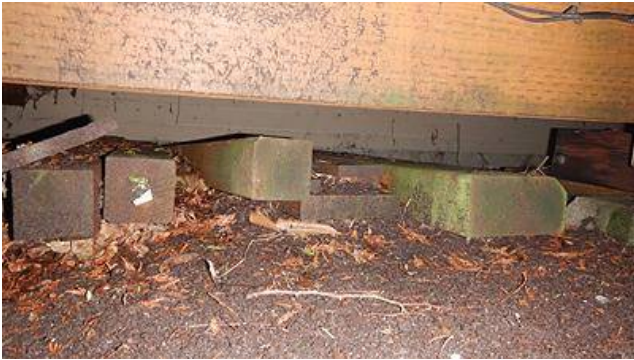
Photo 4-1

4) *Repair/Maintain, Conductive conditions* - Scrap/rotted wood was observed under the deck. The wood is conducive to wood destroying organisms. All scrap/rotted wood around the house and under decks should be removed.

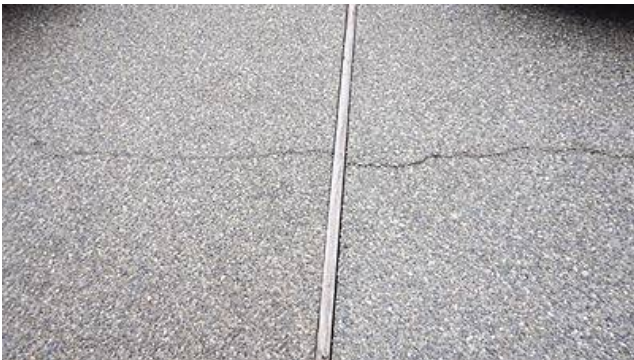
Photo 5-1

5) *Maintenance Item* - Cracks were observed in the driveway. Typically these areas have settled and stopped. The cracks could be sealed to prevent water infiltration and further settlement. Numerous products exist to seal such cracks including hydraulic cement, non-shrinking grout, resilient caulks and epoxy sealants.

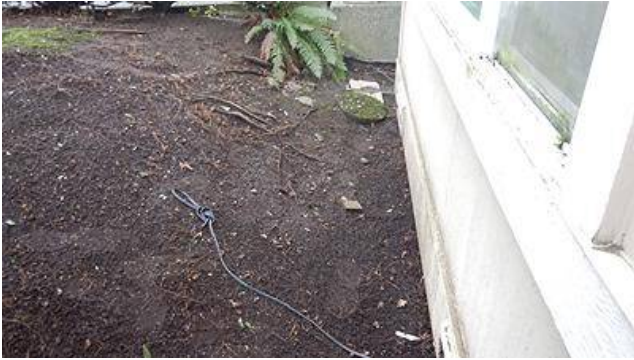
Photo 6-1

6) *Monitor* - The grading slopes down towards the house perimeter on the south side. This condition can result in water accumulating around foundation and/or leaking into the crawl space. No signs of crawl space water accumulation were observed at the time of the inspection. Recommend monitoring the surface drainage and, if necessary, installing a French drain, (buried drain pipe surrounds by rock) to direct surface drainage away from the structure.

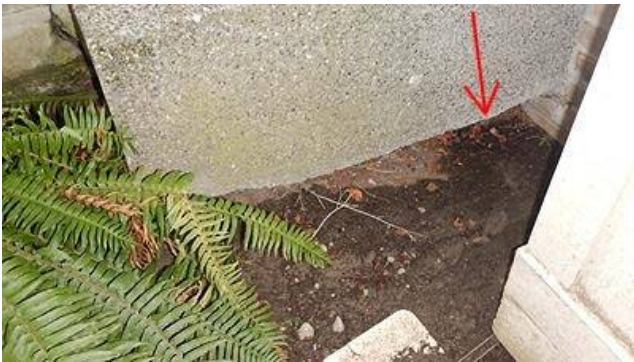
Photo 7-1

7) *Monitor* - Soil erosion was observed from under the east side of the entry porch. The porch has not settled due to the soil erosion. The porch should be monitored and if settlement occurs, the erosion under the porch should be repaired by a qualified contractor.

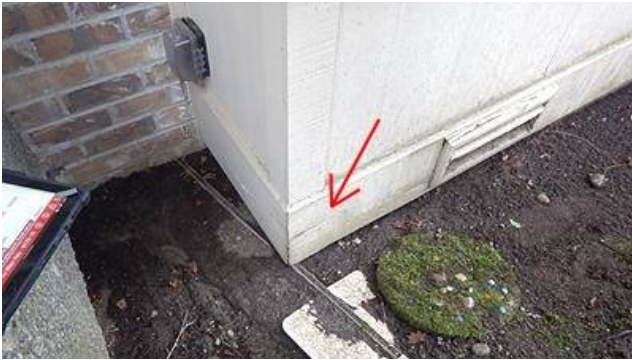
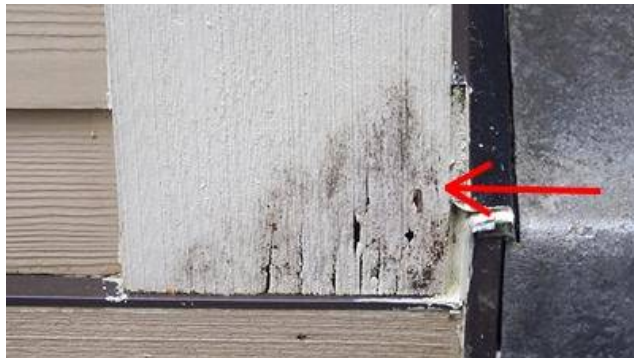
11) *Minor Concern* - A) Fungal rot was found at one or more locations on the south side of the house. Rot damage was found at the: lower trim of the southwest corner of living room bump out, trim at the base of the entry porch post and at the south gable end vent above the garage doors. Additional hidden rot may exist, further investigation is advised. All rotten wood should be replaced as necessary.

B) Fungal rot was also found at the lower, corner trim adjacent to the patio door. Additional hidden rot may exist, further investigation is advised. All rotten wood should be replaced as necessary.

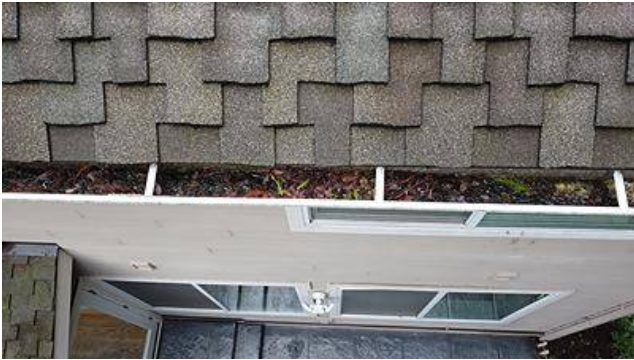
Photo 13-1

13) *Repair/Maintain* - Significant amounts of debris have accumulated in the gutters and/or downspouts. Gutters can overflow and cause water to come in contact with the building exterior, or water can accumulate around the foundation. Recommend cleaning gutters and downspouts now and as necessary in the future.

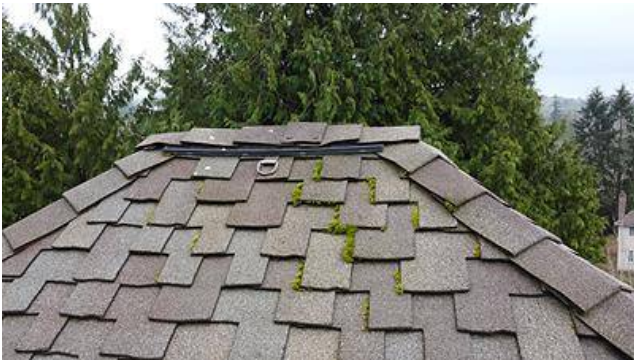
Photo 14-1

14) *Repair/Maintain* - Moss was growing on the roof. As a result, shingles can lift or be damaged. Leaks can result and/or the roof surface can fail prematurely. Efforts should be made to kill the moss during its growing season (wet months). Typically, zinc or phosphate-based chemicals are used for this and must be applied periodically. For information on various moss treatment products and their pros and cons, visit:

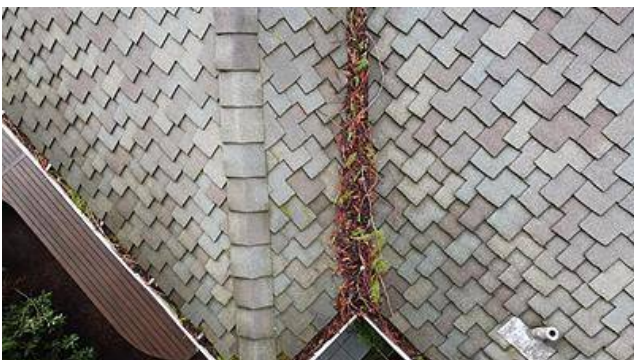
Photo 15-1

15) *Maintenance Item* - Debris such as leaves, needles, etc. have accumulated on the roof surface. Water may not flow easily off the roof and can enter gaps in the roof surface. Leaks can occur as a result. Recommend cleaning debris from the roof surface now and as necessary in the future.

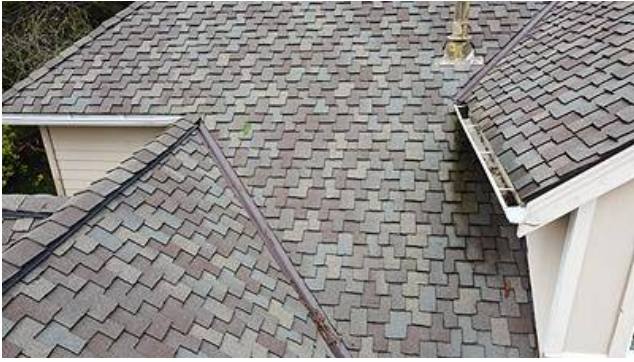
Photo 16-1

16) *Comment* - No signs of shingle erosion were observed.

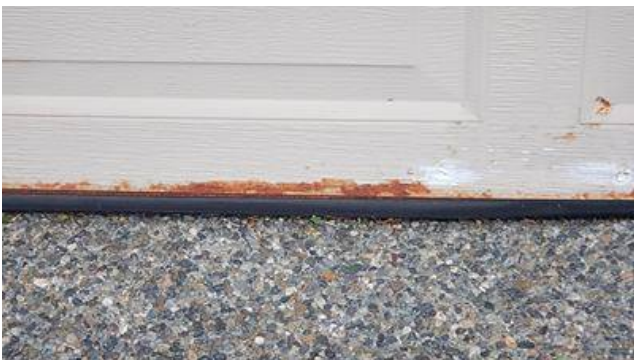
Photo 19-1

19) *Repair/Replace* - The garage door are rusting at the bottoms (exterior) and the bottom of the middle door is broken. Recommend that a qualified contractor repair or replace and/or repair door(s) as necessary.

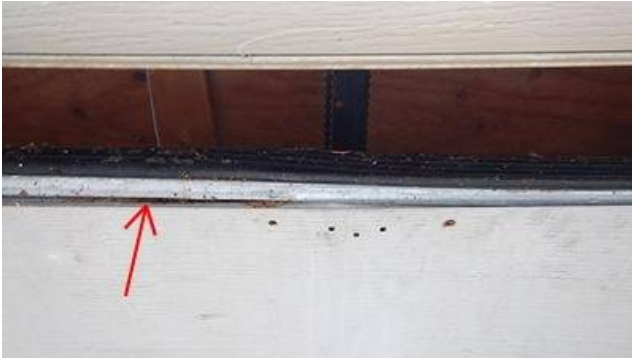
Photo 19-3 Damaged bottom edge of middle garage door.

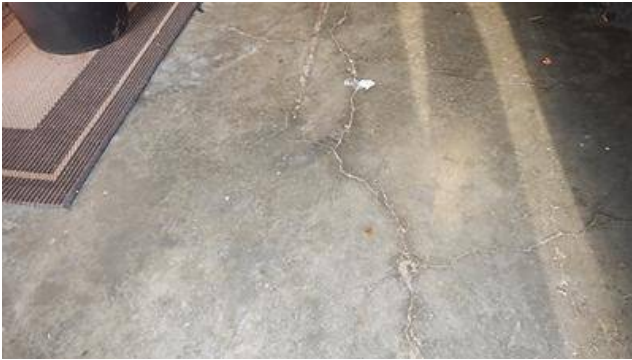
Photo 21-1

21) *Comment* - Minor cracks were found in the concrete slab floor. These are common and are caused by normal concrete settlement. No signs of ongoing settlement were observed.

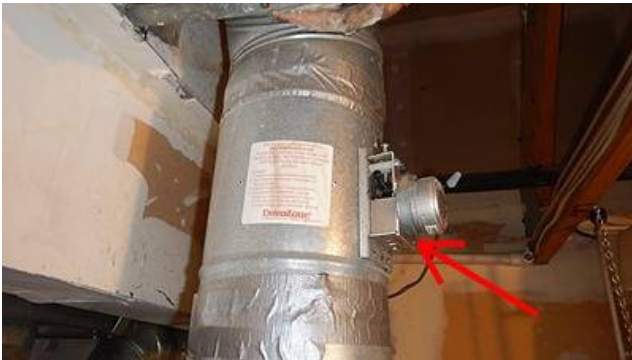
B) The air intake damper did not operate when the system was tested. Recommend that a qualified HVAC contractor evaluate and repair as necessary.

Photo 24-1 Malfunctioning fresh air intake damper.

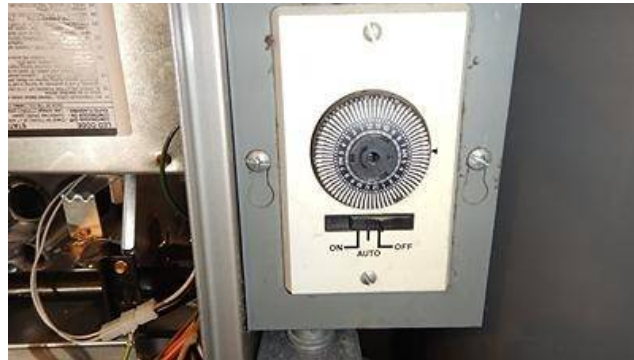
Photo 24-2 Timer control for the fresh air system. The timer is not set for automatic operation.

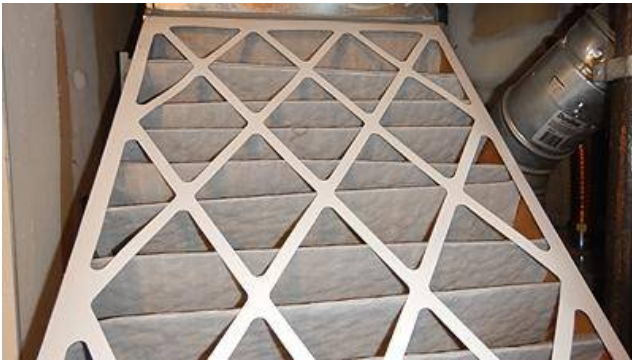
Photo 25-1

25) *Repair/Maintain* - The furnace filters are dirty. Filters should be changed or cleaned every three to four months during the heating season. The filter should be changed or cleaned at this time.

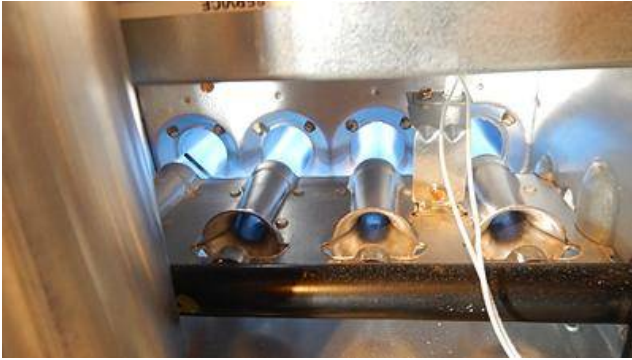
Photo 26-1

26) *Maintenance Item* - The furnace operated properly at the time of the inspection. The last furnace service was not posted on the furnace. Gas furnaces should be serviced every one to two years. If the inspector was unable to determine the last service date, the property owner should be asked. We recommend that a qualified HVAC contractor inspect, clean, and service the furnace if not done in the last year or two. Any needed repairs noted in this report should be brought to the attention of the HVAC contractor when it's serviced. For more information visit:

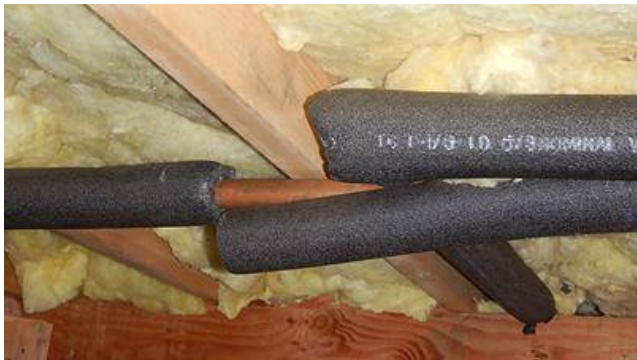
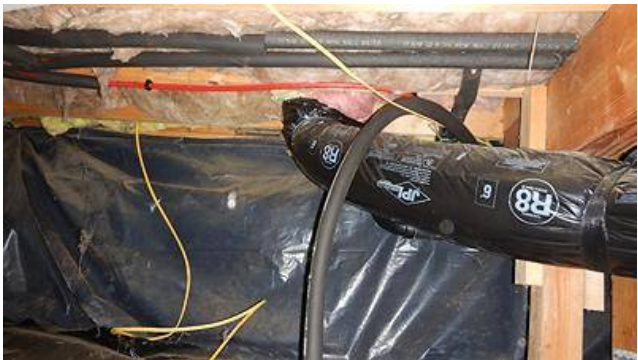
27) *Repair/Replace* - Insulation for one or more water supply pipes in the crawl space was missing and/or loose. Recommend replacing or installing insulation on pipes per standard building practices to prevent them from freezing during cold weather, and for better energy efficiency with hot water supply pipes.

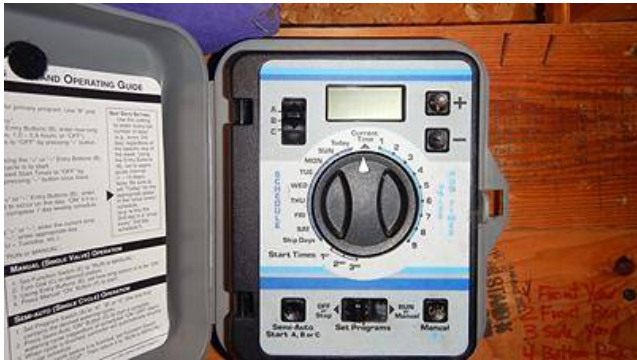
Photo 28-1

28) *Comment* - Based on visible equipment, this property appeared to have a yard irrigation (sprinkler) system. These are specialty systems and are excluded from this inspection. Comments in this report related to this system are made as a courtesy only and are not meant to be a substitute for a full evaluation by a qualified specialist. When this system is operated, recommend verifying that water is not directed at building exteriors, or directed so water accumulates around building foundations. Sprinkler heads may need to be adjusted, replaced or disabled. Recommend that a qualified plumber verify that a backflow prevention device is installed per standard building practices to prevent cross-contamination of gray water and potable water. Recommend that a qualified specialist evaluate the irrigation system for other defects (e.g. leaks, damaged or malfunctioning sprinkler heads) and repair if necessary.

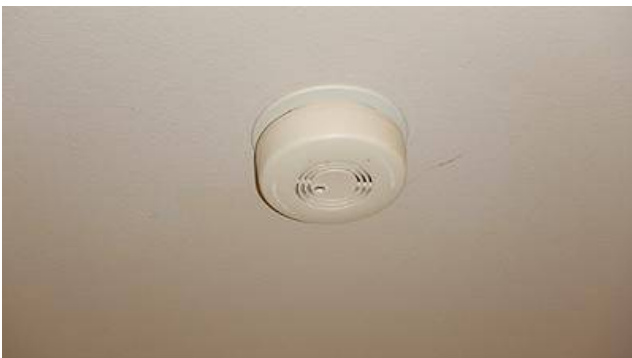
Photo 30-1

30) *Safety Hazard* - Based on the age of this structure and the appearance of existing smoke alarms, the alarms have been installed more than 10 years ago. According to [National Fire Protection Association](#), aging smoke alarms don't operate as efficiently and often are the source for nuisance alarms. Most manufacturers also recommend replacing the smoke alarms after ten years. Recommend replacing all hard-wired smoke detectors as recommended by NFPA. For more information, visit: <https://www.reporthost.com/?SMKALRMLS>

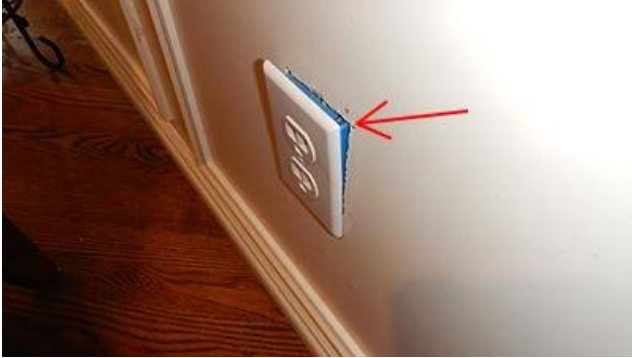
Photo 32-1

32) *Repair/Replace* - One receptacle box was loose at the first floor, hallway wall, near the entry. This is a potential safety hazard for shock or fire. Recommend that a qualified electrician repair as necessary.

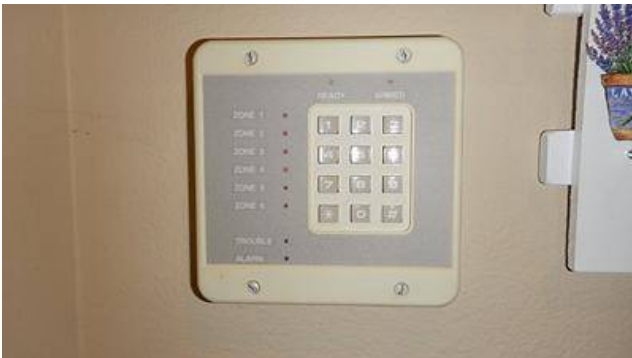
Photo 33-1

33) *Comment* - The security system was not tested or inspected. The inspection of this system is beyond the scope of an ASHI inspection. The home owner or a specialty contractor familiar with the system should be consulted for testing, proper operation and care of the system.

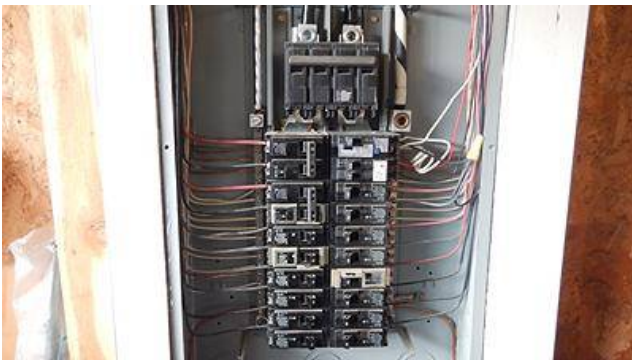
Photo 34-1

34) *Comment* - No concerns observed with the breaker panel wiring.

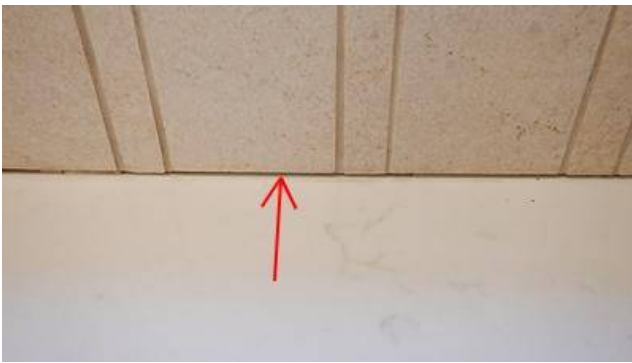
Photo 35-1

35) *Repair/Maintain* - Gaps, no caulk, or substandard caulking were found between the countertop and backsplash. Water may penetrate these areas and cause damage. Recommend repairing the damaged areas as necessary. For example, by installing caulk.

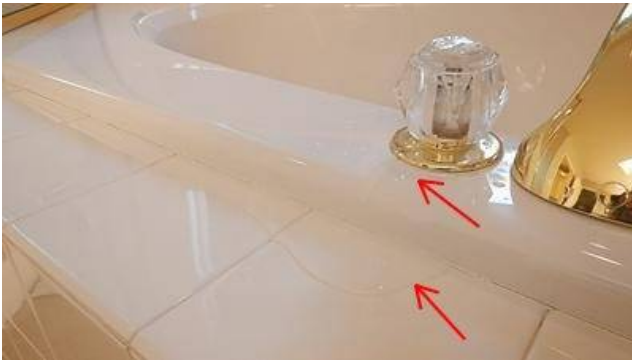
Photo 36-1

36) *Minor Concern* - The hot water, bathtub faucet at location #C (primary bathroom) was leaking. Recommend that a qualified person repair or replace handles as necessary.

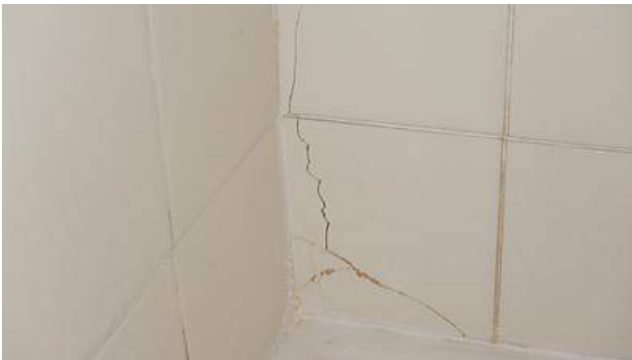
Photo 37-1

37) *Repair/Replace* - Tiles in the lower, left corner of the shower enclosure at location #C were cracked. Water can damage the wall structure as a result. Recommend that a qualified contractor repair as necessary.

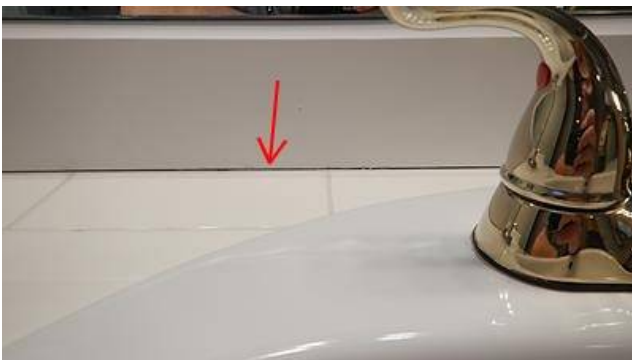
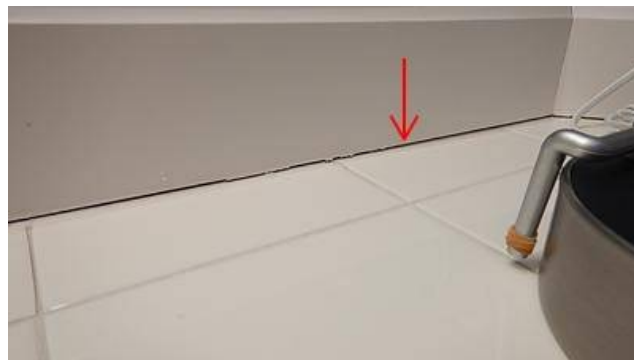
38) *Repair/Maintain* - Gaps, no caulk, or substandard caulking were found between countertops and backsplashes at location(s) #C. Water can penetrate these areas and cause damage. Recommend that a qualified person repair as necessary. For example, by installing or replacing caulk.

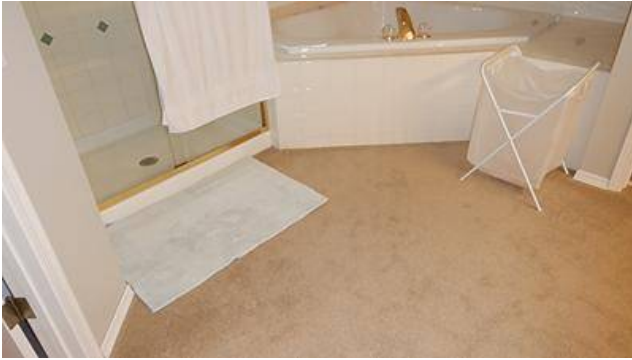
Photo 39-1

39) *Monitor* - The bathroom floor at location #C is covered with carpet. Only a limited inspection of the structural floor could be performed. Hidden rot damage could exist. Carpet is not recommended in this area because it can trap moisture against the wood sub-floor near the shower and bathtub. The sub-floor was not tested for moisture because the house is vacant and the sub-floor would be dry. The carpet should be removed and sheet vinyl or tile flooring installed.

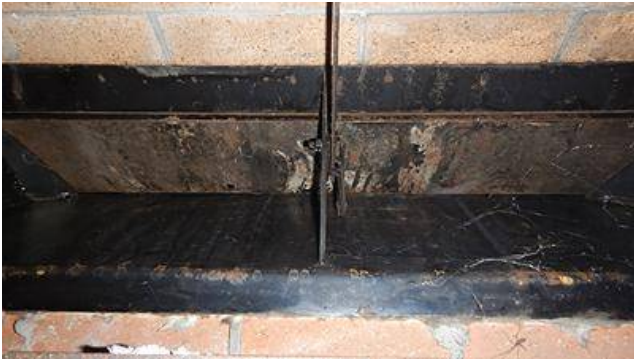
Photo 41-1

41) *Safety Hazard* - The living room fireplace was equipped with a gas burner and the chimney damper can fully close. This is a safety hazard due to the possibility of burner exhaust gases entering the living space. Modifications should be made to prevent the damper from fully closing, by installing a C-clamp safety device. A qualified contractor should repair per standard building practices so the damper cannot fully close.

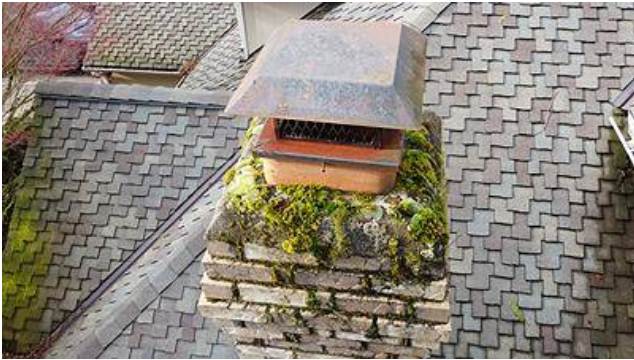
Photo 42-1

42) *Repair/Replace* - The masonry chimney crown is completely covered with moss. The condition of the chimney crown could not be inspected. Hidden cracks could exist which allow water to enter the masonry chimney. If possible, (the chimney is very tall) the moss should be cleaned off and the crown inspected for damage and repaired as needed.

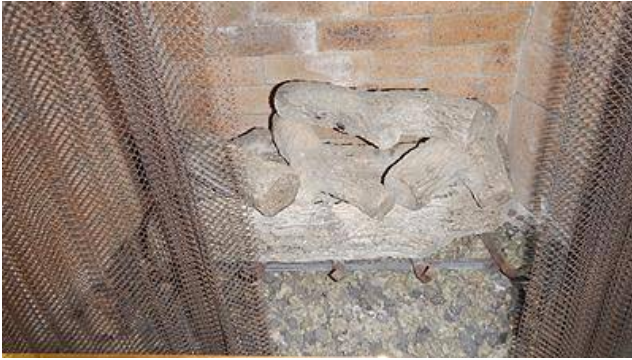
Photo 43-1

43) *Comment* - The function of the gas log burner in the livingroom fireplace could not be tested because it requires a match (open flame) to ignite the burner. Activating gas appliances with an open flame is beyond the scope of an ASHI home inspection. The operation of the gas log should be verified prior to closing.

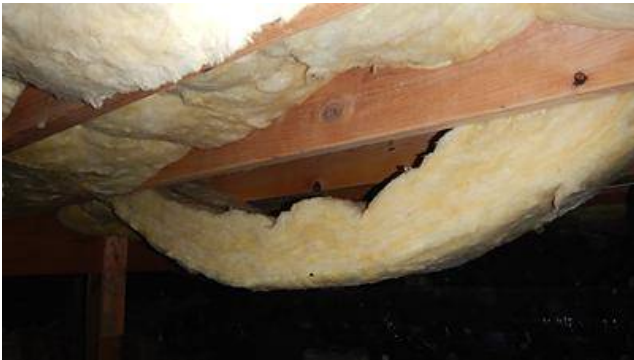
Photo 46-1

46) *Repair/Maintain* - Some sections of under-floor insulation in the crawl space have fallen down. This may result in reduced energy efficiency. Recommend that a qualified contractor install or replace insulation as necessary.

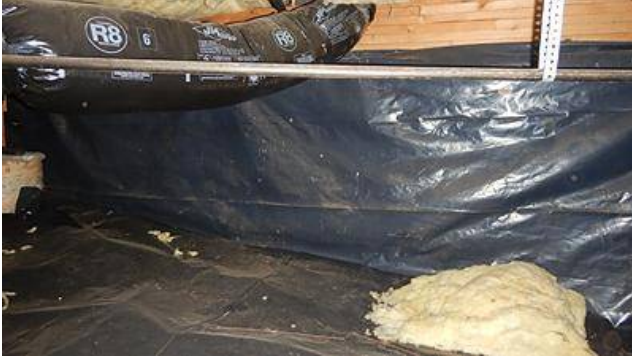
Photo 47-1

47) *Appeared Serviceable* - The structure appears to be square and level. No cracks were observed in the foundation. Many foundation walls below the house were obscured by the vapor barrier. The inspector was unable to evaluate these areas. They are excluded from this inspection.
