### ASHI HOME INSPECTION REPORT

Property address: 10716 - 51st St NE

Inspection date: Tuesday, January 7, 2025

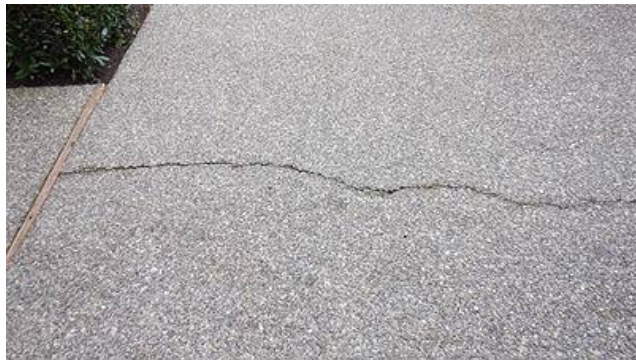
Photo 5-2

5) *Maintenance Item* - Cracks were observed in the driveway. Typically these areas have settled and stopped. The cracks could be sealed to prevent water infiltration and further settlement. Numerous products exist to seal such cracks including hydraulic cement, non-shrinking grout, resilient caulks and epoxy sealants.

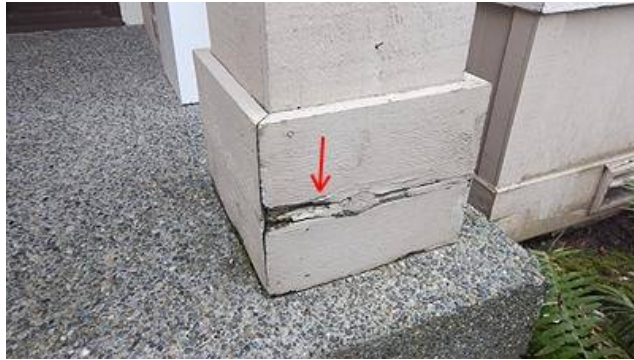
Photo 11-2

11) *Minor Concern* - A) Fungal rot was found at one or more locations on the south side of the house. Rot damage was found at the: lower trim of the southwest corner of living room bump out, trim at the base of the entry porch post and at the south gable end vent above the garage doors. Additional hidden rot may exist, further investigation is advised. All rotten wood should be replaced as necessary.

B) Fungal rot was also found at the lower, corner trim adjacent to the patio door. Additional hidden rot may exist, further investigation is advised. All rotten wood should be replaced as necessary.

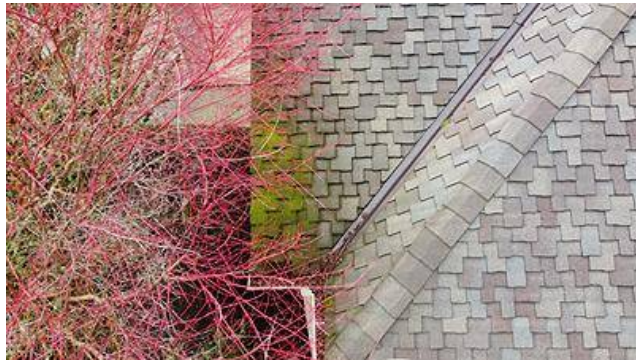
Photo 14-2

14) *Repair/Maintain* - Moss was growing on the roof. As a result, shingles can lift or be damaged. Leaks can result and/or the roof surface can fail prematurely. Efforts should be made to kill the moss during its growing season (wet months). Typically, zinc or phosphate-based chemicals are used for this and must be applied periodically. For information on various moss treatment products and their pros and cons, visit:

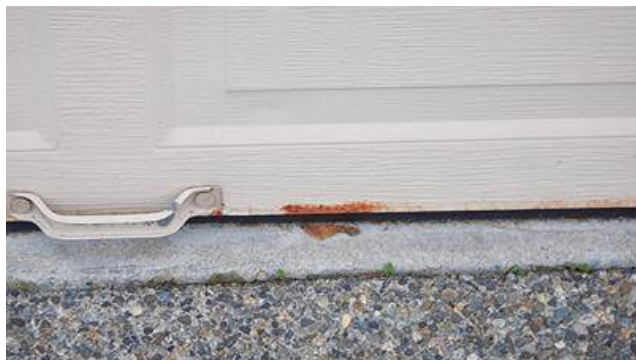
Photo 19-2

19) *Repair/Replace* - The garage door are rusting at the bottoms (exterior) and the bottom of the middle door is broken. Recommend that a qualified contractor repair or replace and/or repair door(s) as necessary.

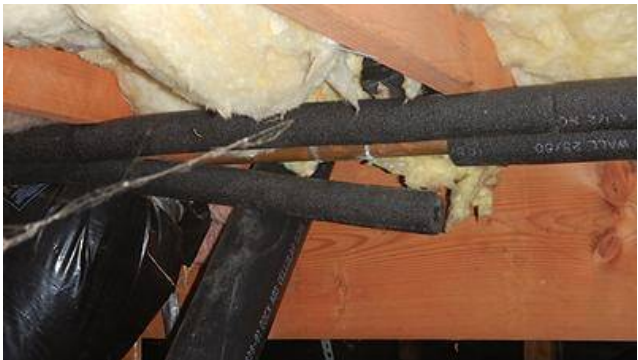
Photo 27-2

27) *Repair/Replace* - Insulation for one or more water supply pipes in the crawl space was missing and/or loose. Recommend replacing or installing insulation on pipes per standard building practices to prevent them from freezing during cold weather, and for better energy efficiency with hot water supply pipes.

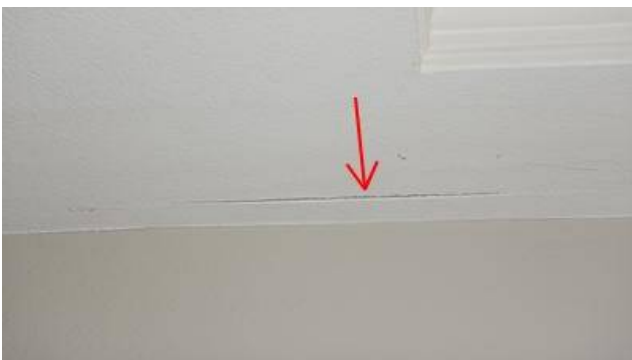
Photo 40-1

40) *Maintenance Item* - Minor cracks and/or blemishes were found in the ceiling by the attic access hatch. Cracks are common, are often caused by lumber shrinkage or minor settlement, and can be more or less noticeable depending on changes in humidity. The cracks are not a structural concern, but the client may wish to repair these for aesthetic reasons. For recurring cracks, consider using an elastic crack covering product:

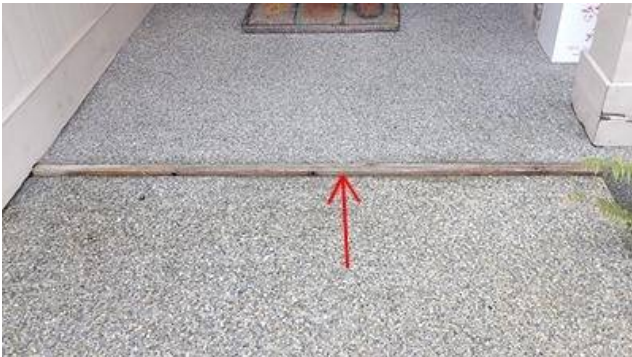
2) *Minor Concern* - Settlement was observed in the entry walk, between the entry porch and the driveway. Part of the driveway has also settled with the walk. Typically, these areas have settled and stopped. The settled walk sections have created trip hazards at the entry porch and the driveway. For safety reasons, recommend repairing these areas to eliminate the trip hazards. For example; by using slab jacking techniques to raise the settled walk and driveway sections. Recommend that a qualified contractor repair this concern as necessary.

Photo 2-1 Trip hazard at concrete divider.

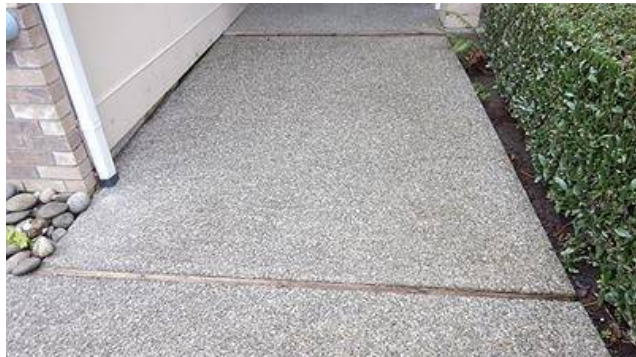
Photo 2-2 Settled walk section.

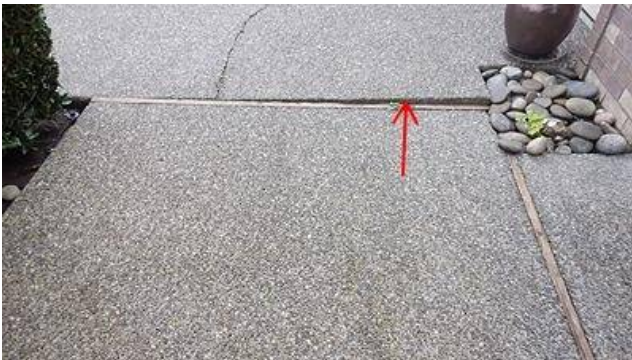
Photo 2-3 Trip hazard at concrete divider.

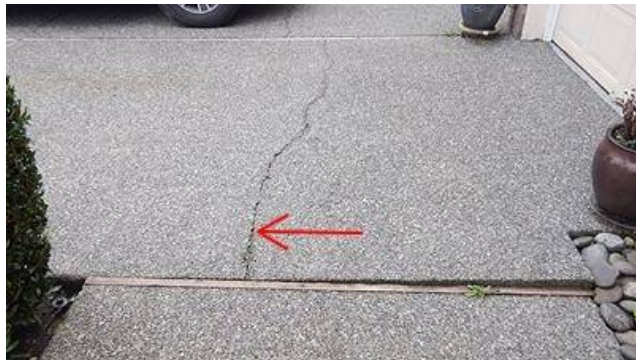
Photo 2-4 Cracked and settled driveway.

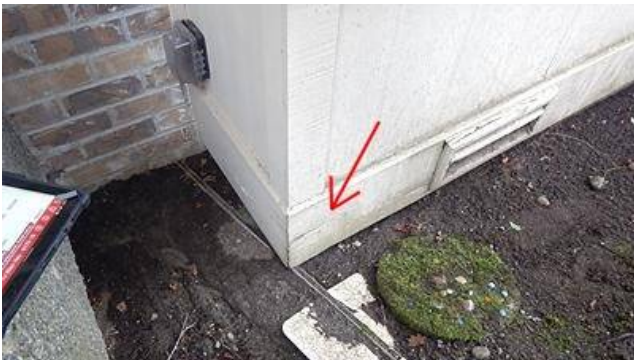
Photo 11-1

11) *Minor Concern* - A) Fungal rot was found at one or more locations on the south side of the house. Rot damage was found at the: lower trim of the southwest corner of living room bump out, trim at the base of the entry porch post and at the south gable end vent above the garage doors. Additional hidden rot may exist, further investigation is advised. All rotten wood should be replaced as necessary.

B) Fungal rot was also found at the lower, corner trim adjacent to the patio door. Additional hidden rot may exist, further investigation is advised. All rotten wood should be replaced as necessary.

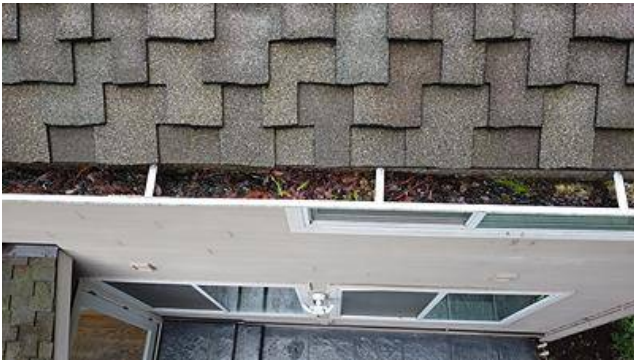
Photo 13-1

13) *Repair/Maintain* - Significant amounts of debris have accumulated in the gutters and/or downspouts. Gutters can overflow and cause water to come in contact with the building exterior, or water can accumulate around the foundation. Recommend cleaning gutters and downspouts now and as necessary in the future.

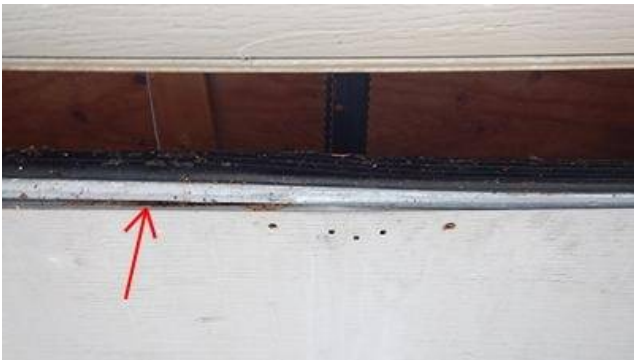
Photo 19-3 Damaged bottom edge of middle garage door.

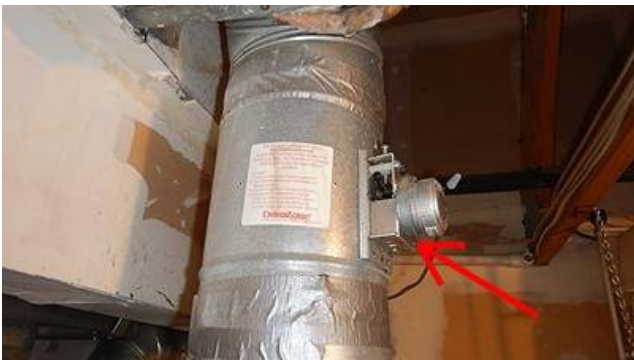
B) The air intake damper did not operate when the system was tested. Recommend that a qualified HVAC contractor evaluate and repair as necessary.

Photo 24-1 Malfunctioning fresh air intake damper.

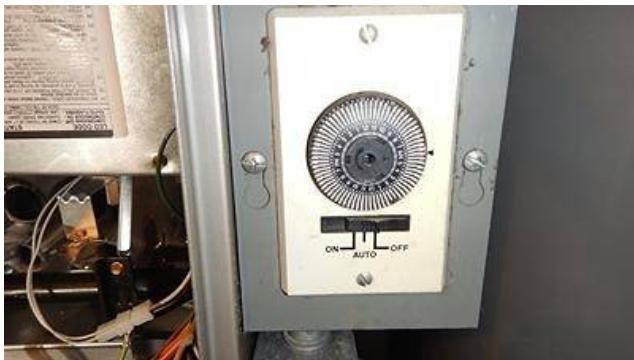
24) *Minor Concern* - A) A fresh makeup air system was installed with a timer. The timer controls the introduction of fresh air into the heating system's return air supply and to activate one exhaust fan. This system is necessary to maintain adequate indoor air quality. Typically, these systems should be activated three times a day for roughly 2 hour per time. The client should familiarize themselves with the timer's operation and by setting the timer as necessary.

Photo 24-2 Timer control for the fresh air system. The timer is not set for automatic operation.

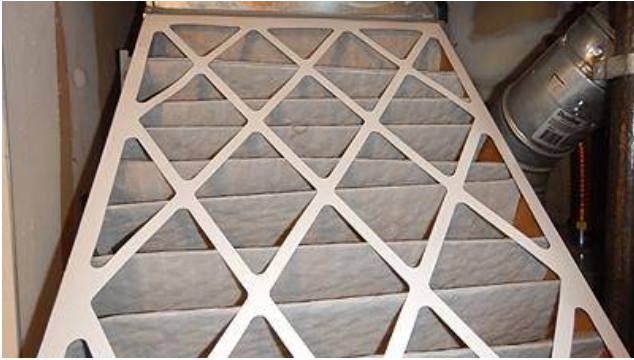
Photo 25-1

25) *Repair/Maintain* - The furnace filters are dirty. Filters should be changed or cleaned every three to four months during the heating season. The filter should be changed or cleaned at this time.

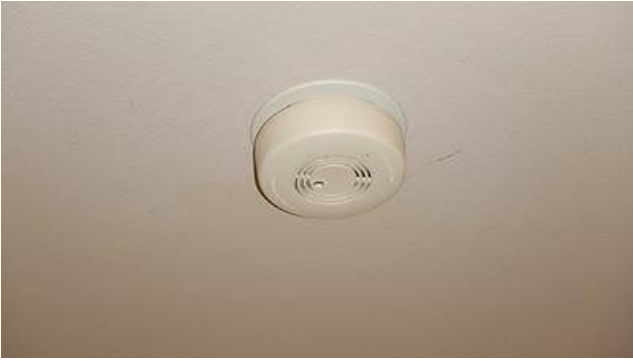
Photo 30-1

30) *Safety Hazard* - Based on the age of this structure and the appearance of existing smoke alarms, the alarms have been installed more than 10 years ago. According to [National Fire Protection Association](https://www.nfpa.org), aging smoke alarms don't operate as efficiently and often are the source for nuisance alarms. Most manufacturers also recommend replacing the smoke alarms after ten years. Recommend replacing all hard-wired smoke detectors as recommended by NFPA. For more information, visit: <https://www.reporthost.com/?SMKALRMLS>

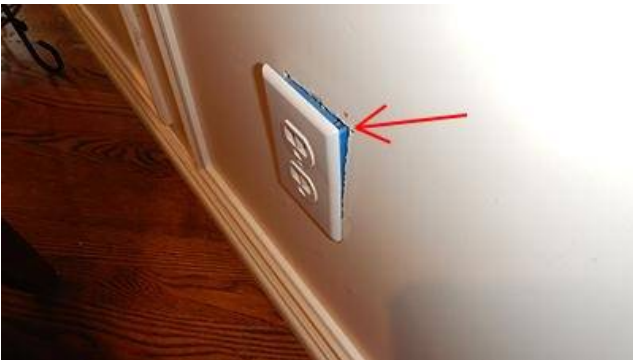
Photo 32-1

32) *Repair/Replace* - One receptacle box was loose at the first floor, hallway wall, near the entry. This is a potential safety hazard for shock or fire. Recommend that a qualified electrician repair as necessary.

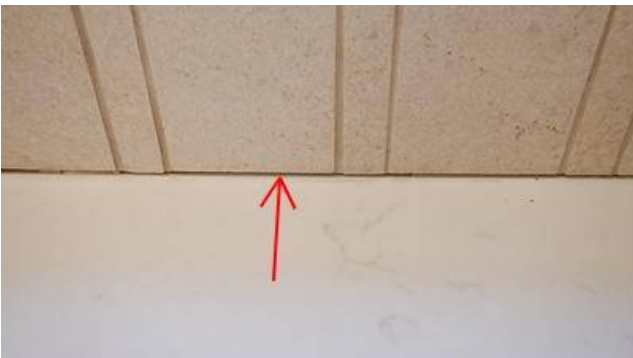
Photo 35-1

35) *Repair/Maintain* - Gaps, no caulk, or substandard caulking were found between the countertop and backsplash. Water may penetrate these areas and cause damage. Recommend repairing the damaged areas as necessary. For example, by installing caulk.

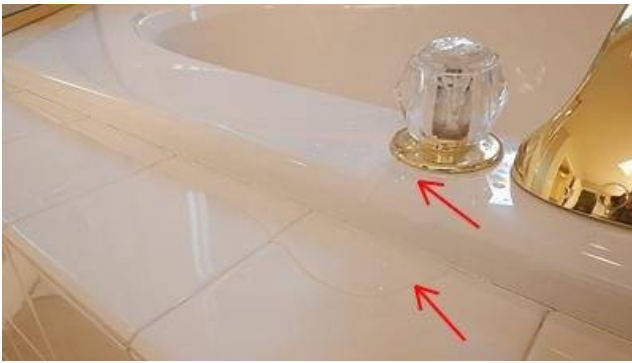
Photo 36-1

36) *Minor Concern* - The hot water, bathtub faucet at location #C (primary bathroom) was leaking. Recommend that a qualified person repair or replace handles as necessary.

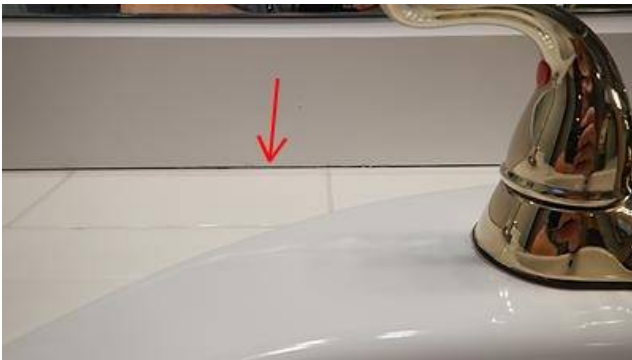
Photo 38-1

38) *Repair/Maintain* - Gaps, no caulk, or substandard caulking were found between countertops and backsplashes at location(s) #C. Water can penetrate these areas and cause damage. Recommend that a qualified person repair as necessary. For example, by installing or replacing caulk.

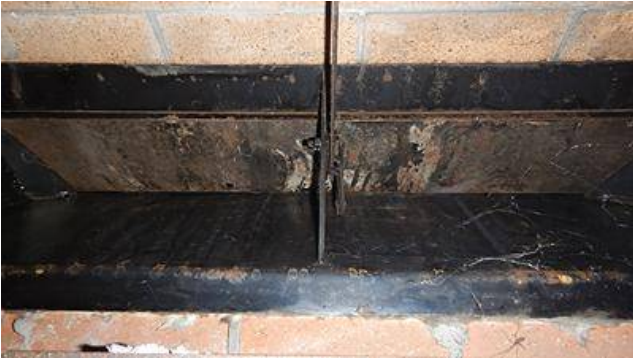
Photo 41-1

41) *Safety Hazard* - The living room fireplace was equipped with a gas burner and the chimney damper can fully close. This is a safety hazard due to the possibility of burner exhaust gases entering the living space. Modifications should be made to prevent the damper from fully closing, by installing a C-clamp safety device. A qualified contractor should repair per standard building practices so the damper cannot fully close.

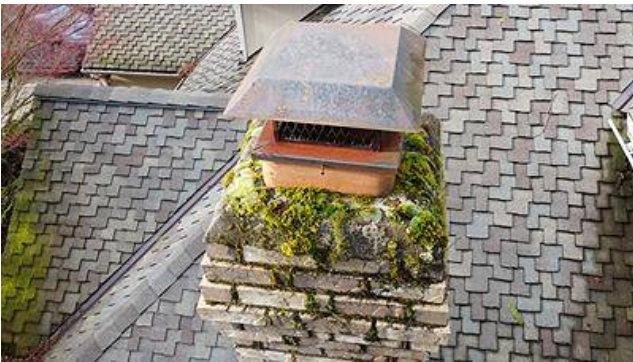
Photo 42-1

42) *Repair/Replace* - The masonry chimney crown is completely covered with moss. The condition of the chimney crown could not be inspected. Hidden cracks could exist which allow water to enter the masonry chimney. If possible, (the chimney is very tall) the moss should be cleaned off and the crown inspected for damage and repaired as needed.

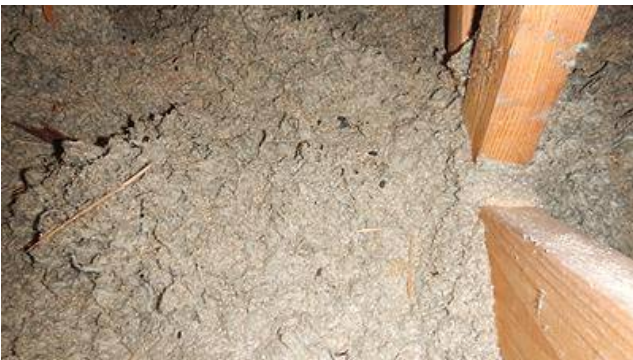
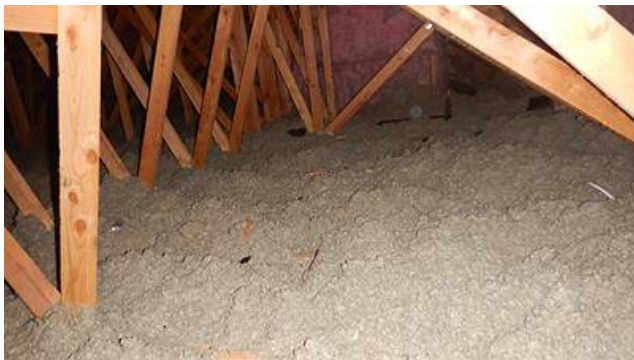
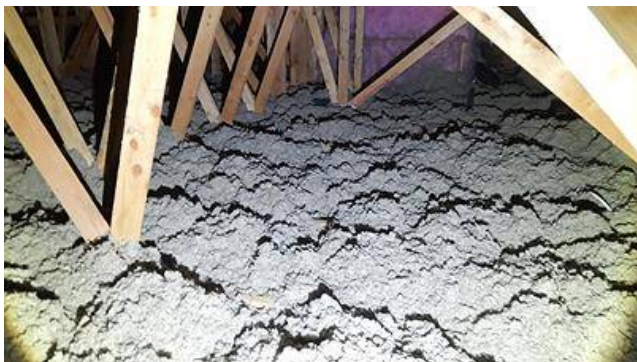
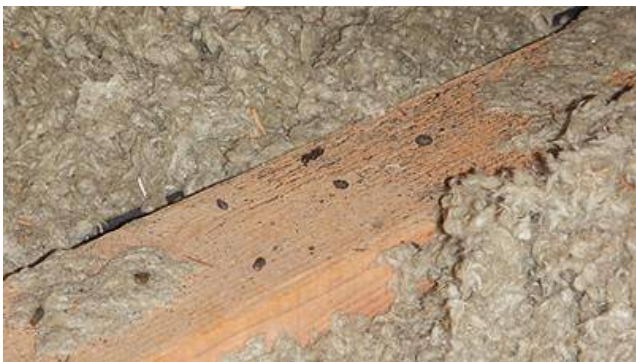
45) *Major Concern* - Evidence of rodent infestation was found in the form of feces and damaged insulation in the attic. A crawl space clean-out contractor should make repairs to remove damaged insulation, clean rodent waste, seal openings in the structure and install new insulation. Recommend following these guidelines from the Center for Disease Control:

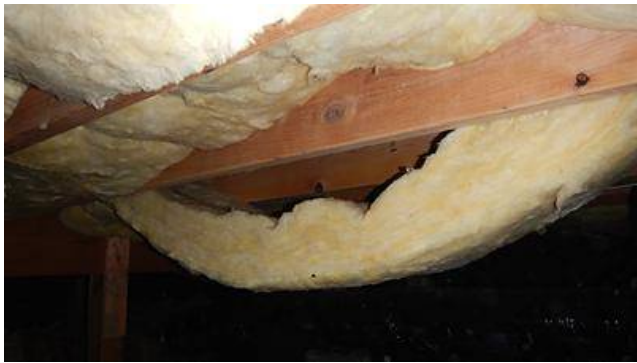
Photo 46-1

46) *Repair/Maintain* - Some sections of under-floor insulation in the crawl space have fallen down. This may result in reduced energy efficiency. Recommend that a qualified contractor install or replace insulation as necessary.
